Conservation Area Appraisals
in the Yorkshire Dales National Park

Clapham

Adopted document

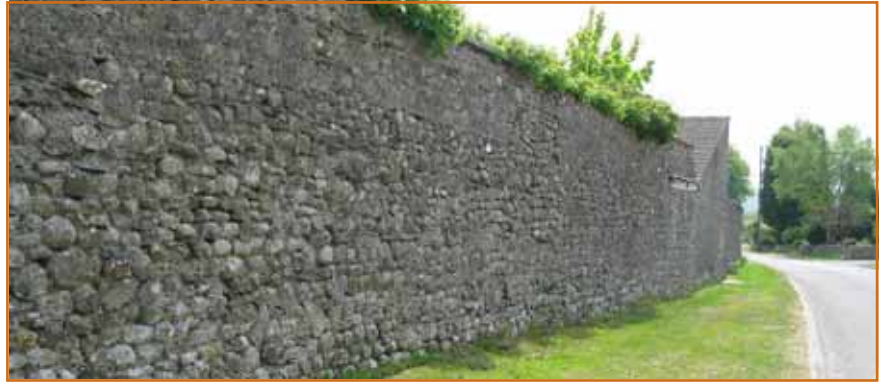
Figure 14: View 7 (photo © Ross Cannon, YDNPA, 2010)

(7). View along east side of Cross Haw Lane with fortification-like boundary walls and gable ends (figure 14).

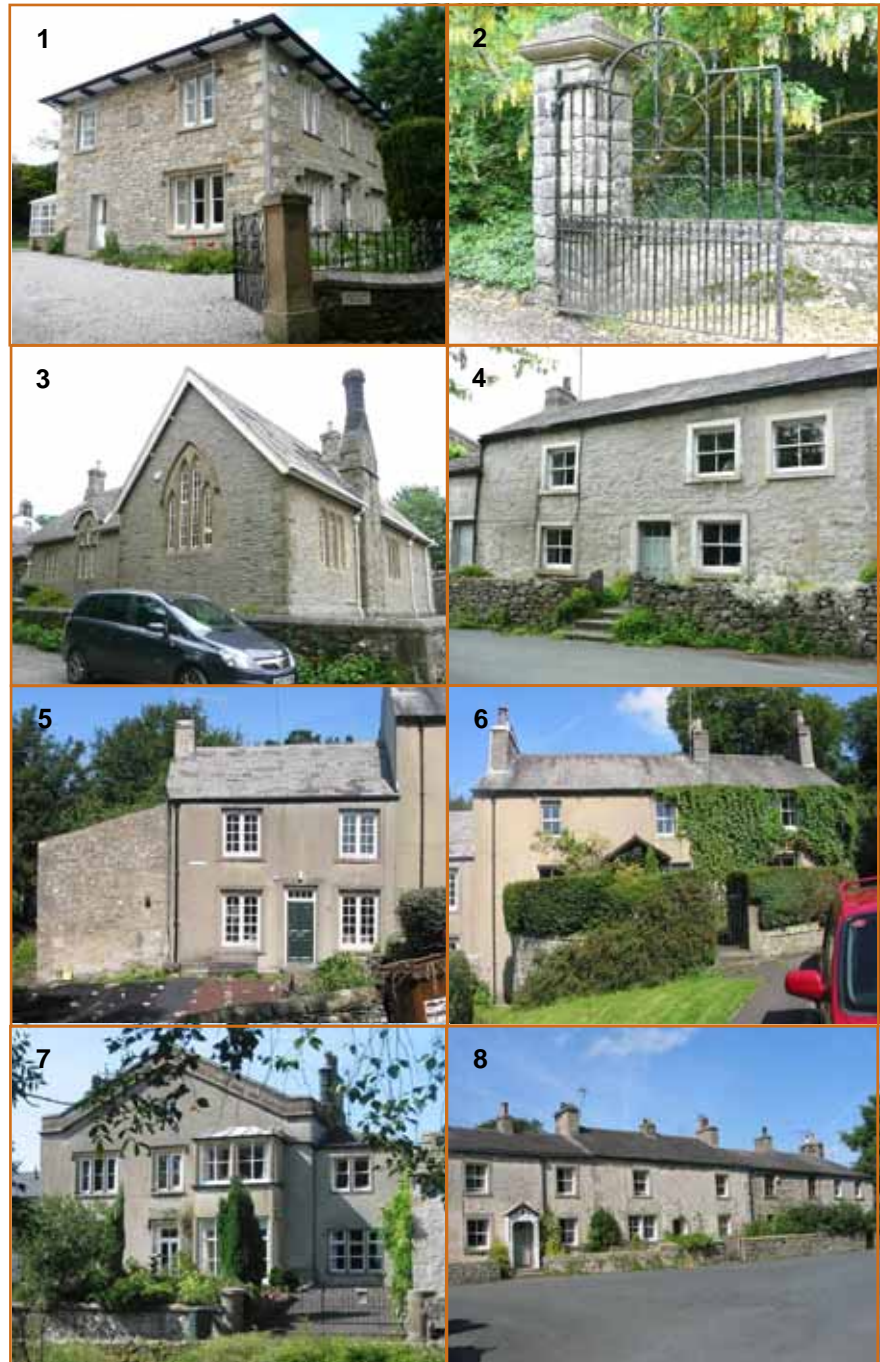
Figure 22: Proposals for local list (photos 1-4 © Gaby Rose, YDNPA, 2010; photos 5-8 © James Innerdale, 2010)

Local list. The following buildings make a particular positive contribution to the conservation area and should be considered for inclusion on a local list (Figure 22):

- **Memorial Fountain, Riverside (Figure 42, image 5):** Erected in 1897 to mark Queen Victoria's Diamond Jubilee. Fish water fountain with shell bowl below set on marble panel. To left return of shelter commemoration

plaque. Panel set in rubble masonry shelter with stone slate roof. Character suggests may have been constructed at a later date to house fountain but no record of this. Repaired 1989 by Tommy Lund, a local builder who still lives in the village.

- **Ivy cottages, Riverside (4):** Probably originally mid to late C18 with C19 and C20 re-fenestration/re-modelling by the Farrers. Early plans suggest originally two houses (now four cottages), with central quoins to right of blocked doorway suggesting left-hand side earlier than right. Unusual central round chimney (to right end of left cottages), detail common in Lake District, but only few examples locally. Shadows of blocked/lost mullioned windows to left half, otherwise openings C19 or C20. Right half has retains of moulded C18 window surrounds to first floor windows, also part repaired/re-formed (?) hood mould over originally three/four light mullioned window to ground floor.

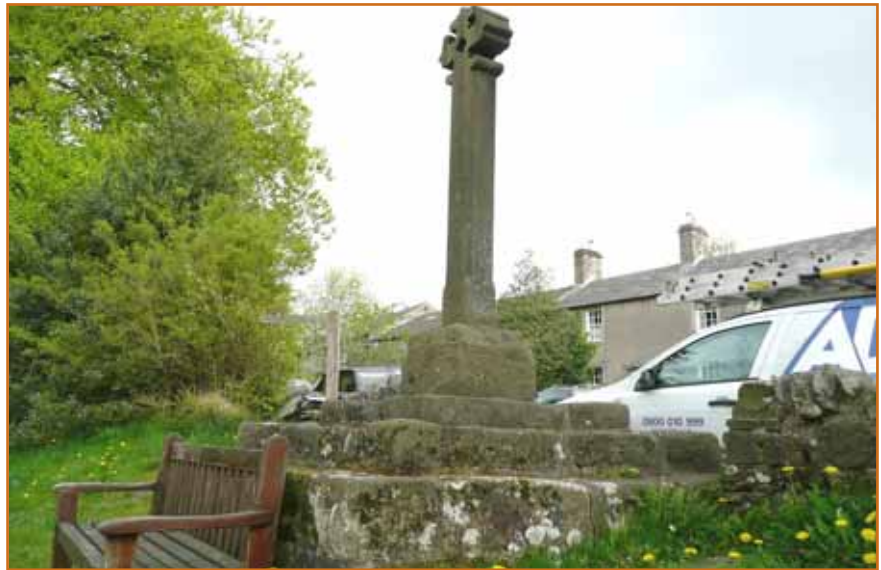
Figure 23: Base to Cross (photo © Gaby Rose, YDNPA, 2010)

- Cross added to base in 1897
- Current condition: good, though several cement mortar joints beginning to crack (no damage to stone)

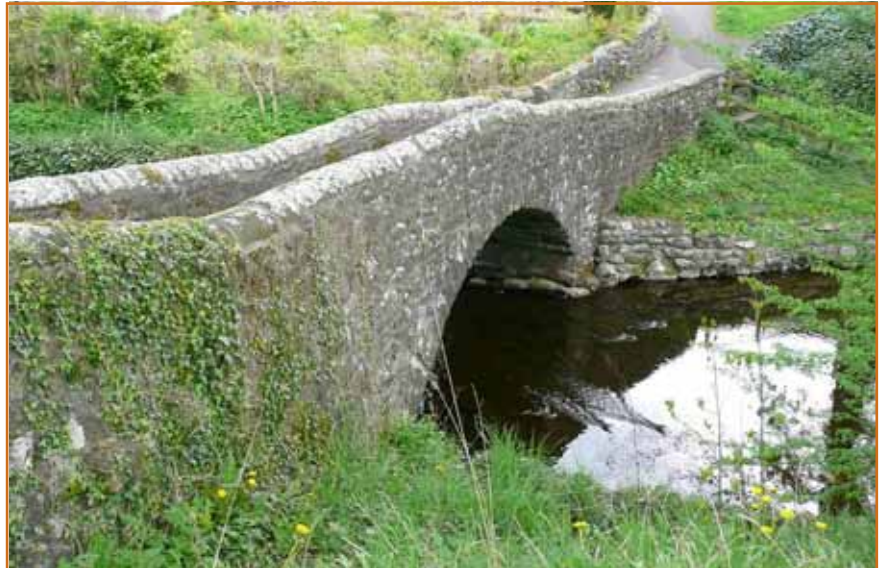
Figure 24: Brokken Bridge (photo © Gaby Rose, YDNPA, 2010)

Brokken Bridge (**figure 24**), grade II listed –

- Footbridge
- Probably C18; rebuilt in 1845 after being swept away; date stone shows that it was repaired in 1913 ¹²
- Slobbered rubble
- Single-span segmental arch
- Current condition: good, though some cement loose

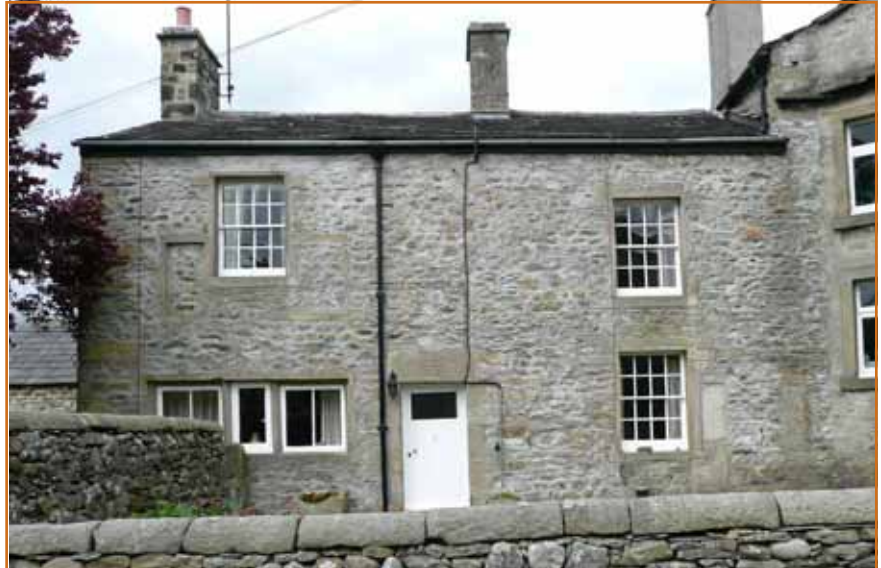
Figure 25: Bull and Cave Farmhouse (photo © Gaby Rose, YDNPA, 2010)

Bull and Cave Farmhouse (**figure 25**), grade II listed –

- Farmhouse
- Dated 1725 with C19 and C20 alterations
- Rendered rubble, stone dressings, stone slate roof
- Central staircase plan
- 2-storey double-fronted building; central entrance with inscribed lintel; former right-hand entrance and upper-floor mullioned window blocked; missing mullions on ground-floor window
- Current condition: good

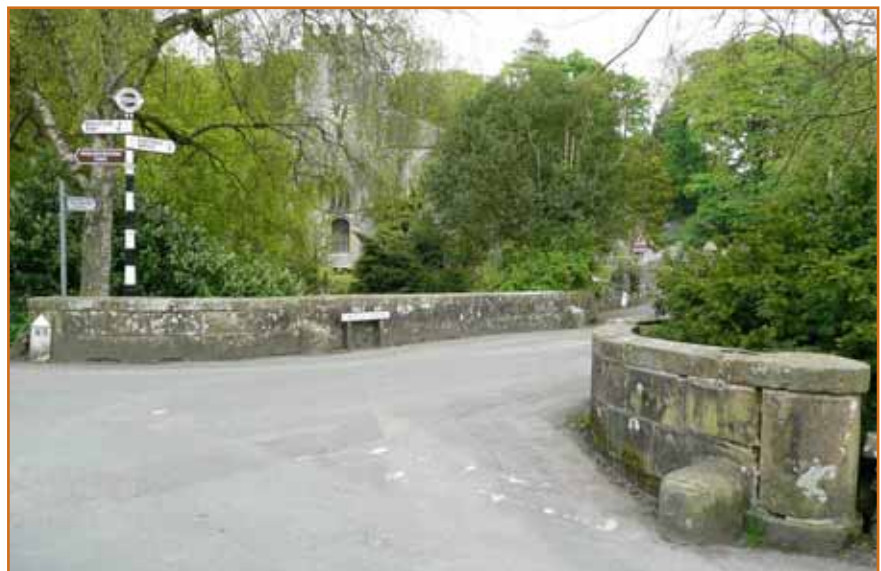
Figure 26: Church Bridge (photo © Gaby Rose, YDNPA, 2010)

Church Bridge (**figure 26**), grade II listed –

- Bridge
- Probably C18; widened on the downstream side by the wapontake in 1798 from eight to twenty feet ¹³
- Rubble to upstream side, ashlar to downstream side and parapets
- Single-span segmental arch with pilasters to either end of parapet and 'newel post' stops to wing walls
- Cast-iron West Riding boundary posts to east and west on upstream side
- Current condition: fair with some plant growth on external face and several deeply eroded or loose mortar joints. Underside of bridge has not been inspected.

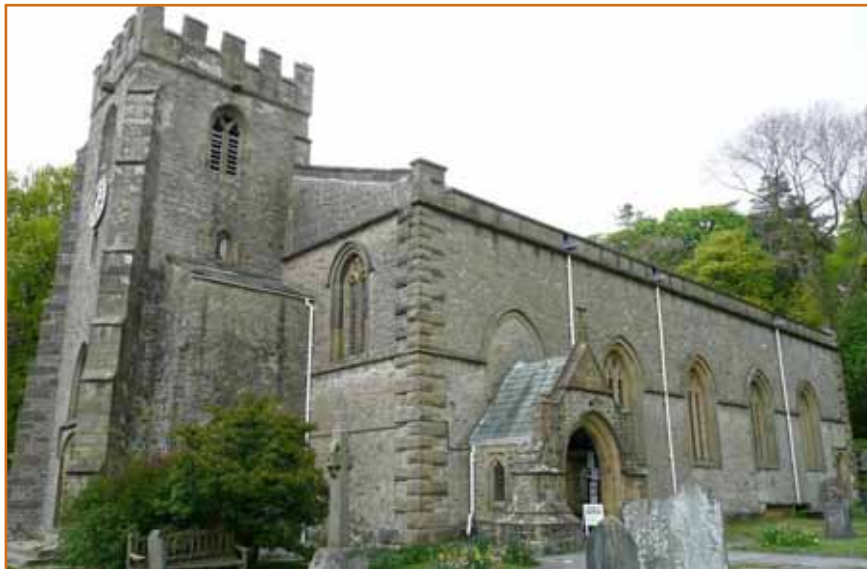
Figure 27: Church of St James
(photo © Gaby Rose, YDNPA,
2010)

Church of St. James (**figure 27**), grade II listed –

- Parish church
- Potentially late C14/early C15 tower, rest 1814 with c.1900 alterations
- Slobbered rubble, stone dressings, thin blue slate roof
- South porch (1899), three-stage west tower, four-bay nave, north and south aisles, one-bay chancel
- Church was rebuilt by Farrer family of Ingleborough Hall
- Current condition: good

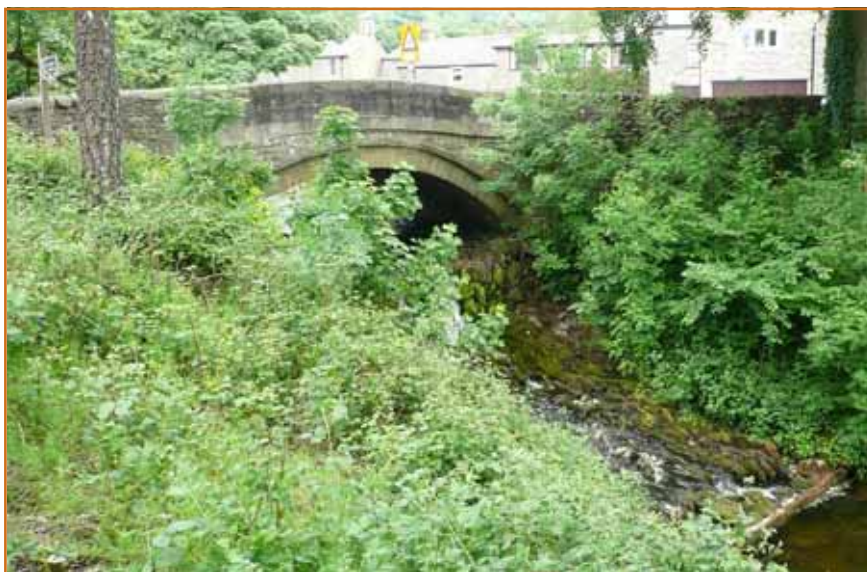
Figure 28: Clapham Bridge
(photo © Gaby Rose, YDNPA,
2010)

Clapham Bridge (**figure 28**), grade II listed –

- Bridge
- C18 with late C19 alterations
- Ashlar and slobbered rubble
- Single-span segmental arch
- Widened on downstream side
- Current condition: good

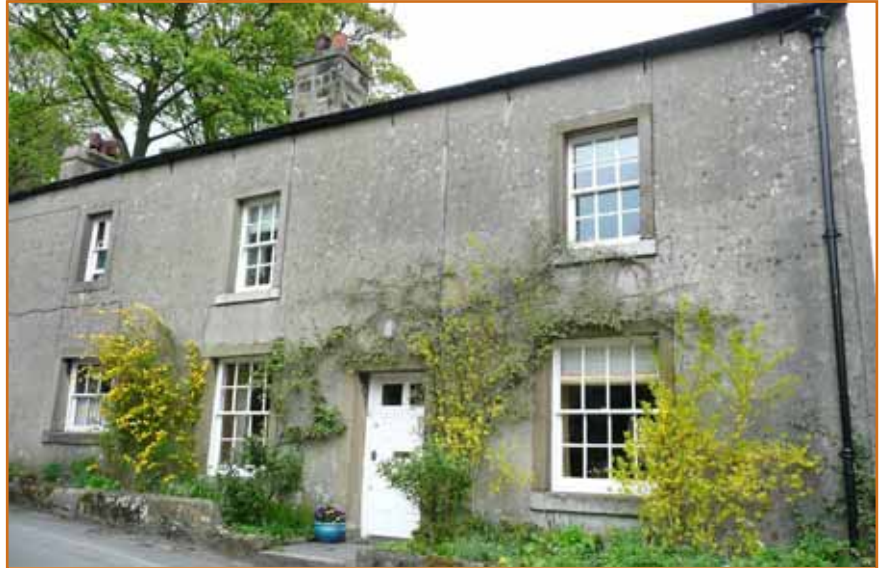
Figure 29: Cottages at Gildersbank (photo © Gaby Rose, YDNPA, 2010)

Cottage at Gildersbank (**figure 29**), grade II listed –

- Cottage
- Early C19 with C17 origins
- Rendered with drawn masonry joints, stone slate roof
- Central staircase plan
- 2-storey 3-bay building with central entrance; sash windows with plain surrounds; C17 stair turret to rear
- Included for group value
- Current condition: good

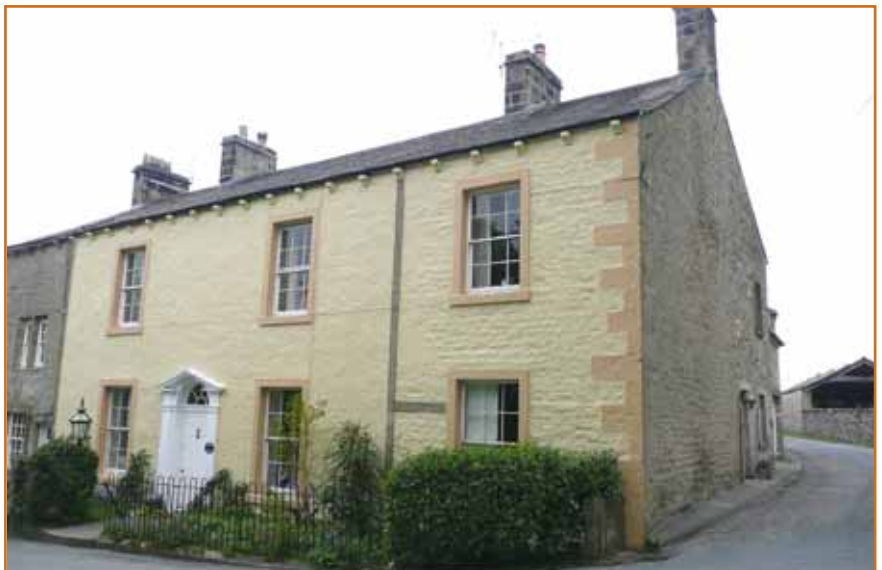
Figure 30: Fall View (photo © Gaby Rose, YDNPA, 2010)

Fall View (**figure 30**), grade II listed –

- House
- Mid C18 with early-C19 alterations
- Pebbledash, painted stone dressings, stone slate roof
- Central staircase plan
- 2-storey 3-bay building; entrance with Tuscan pilasters, open pediment and fanlight; sash windows with plain surrounds and projecting sills; original former entrance at rear with moulded surround now blocked
- Current condition: good

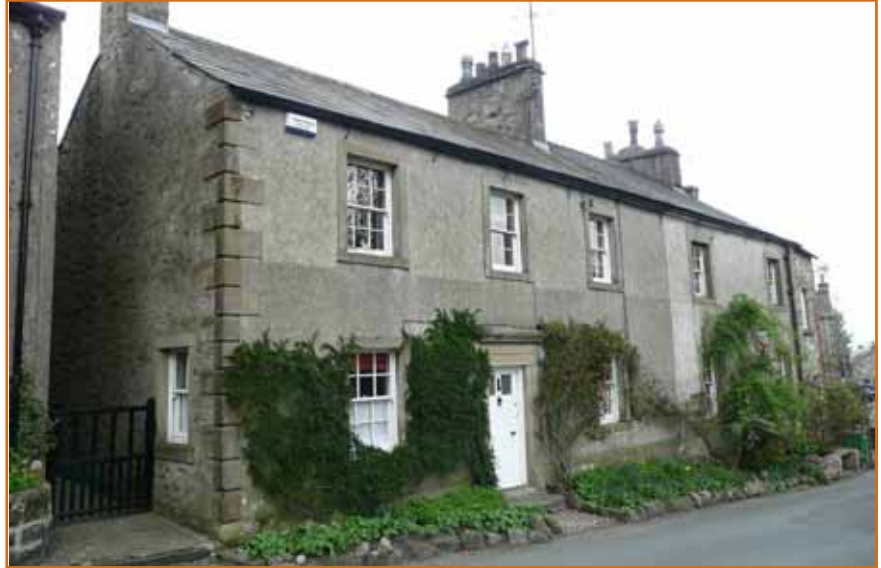
Figure 31: Gildersbank Cottage & Spindle Tree Cottage (photo © Gaby Rose, YDNPA, 2010)

Gildersbank Cottage & Spindle Tree Cottage (**figure 31**), grade II listed –

- Reputedly former Spindle Tree Inn, now two cottages
- Late C18 with C19 alterations
- Rendered with drawn masonry joints, stone dressings, stone slate roof
- Gildersbank Cottage: central staircase plan
- 2-storey building; sash windows with plain surrounds
- Current condition: good

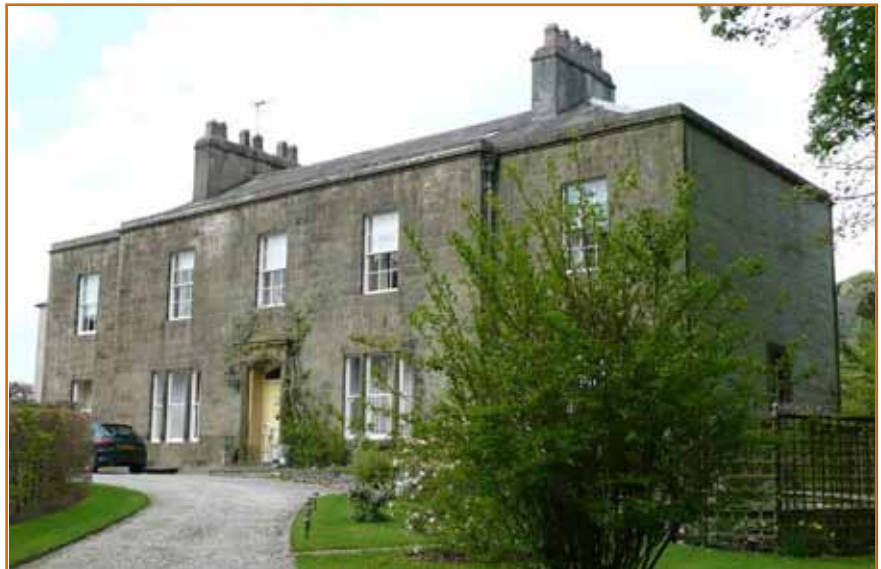
Figure 32: Hall Garth (photo © Gaby Rose, YDNPA, 2010)

Hall Garth (**figure 32**), grade II listed –

- Former land agent's house with office at one end; still used as both house and Ingleborough Estate office
- Late C18; finished in 1833¹⁴
- Ashlar, slate roof
- Central staircase plan
- 2-storey 5-bay building; central entrance with engaged Tuscan columns; sash windows; ground-floor tripartite windows with engaged columns; chimney stacks with 5 and 8 flues
- Built for the agent of Ingleborough Estate
- Current condition: good

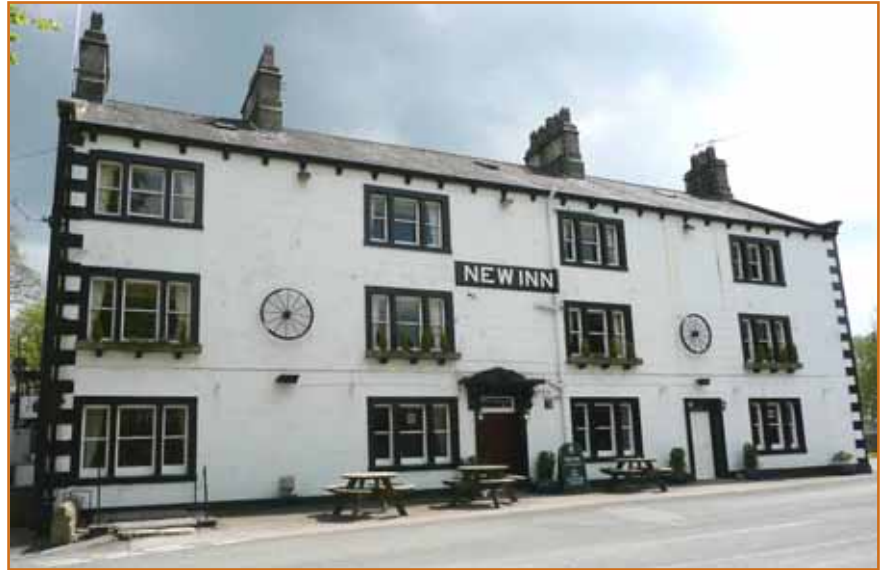
Figure 33: New Inn (photo © Gaby Rose, YDNPA, 2010)

New Inn (**figure 33**), grade II listed –

- Current condition: good, although render is a bit grubby in places

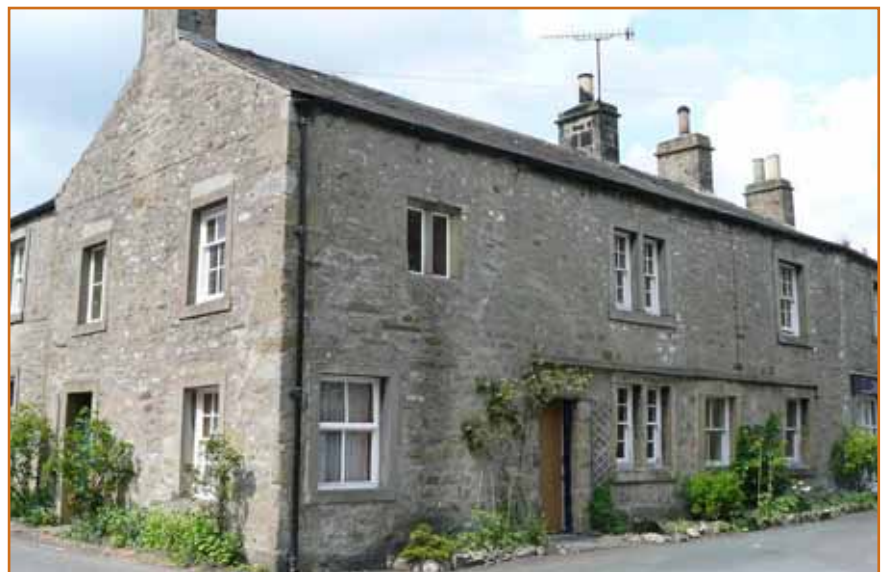
Figure 34: Rose Cottage (photo © Gaby Rose, YDNPA, 2010)

Rose Cottage (**figure 34**), grade II listed –

- Cottage
- Mid C18 with C20 alterations
- Slobbered rubble, stone dressings, stone slate roof
- 2-storey building with continuous hoodmould over rusticated stone doorway and three ground-floor windows
- Current condition: good

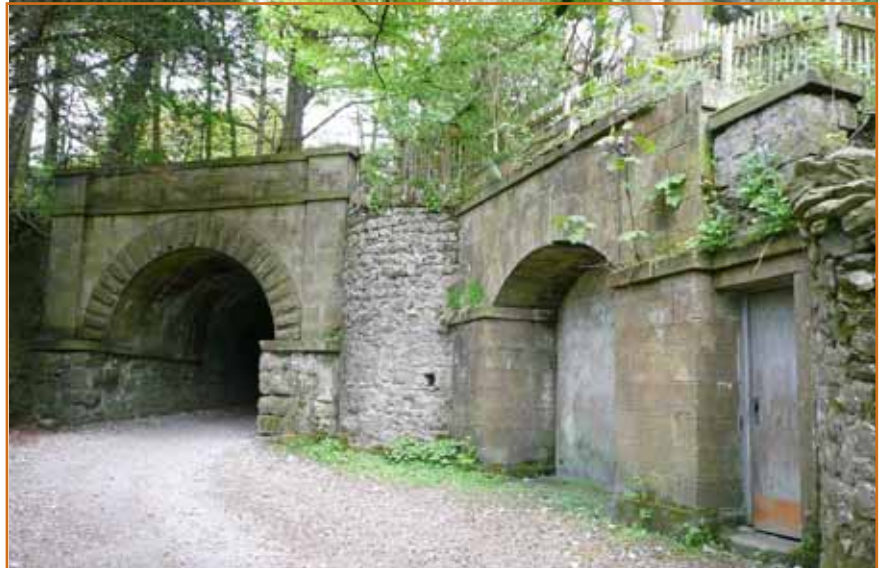
Figure 35: Servants' tunnel to Ingleborough Hall (photo © Gaby Rose, YDNPA, 2010)

Servants' tunnel to Ingleborough Hall (**figure 35**), grade II listed –

- Principal purpose to provide new route for Thwaite Lane, further from the Hall, as Farrers were insistent on their privacy; northern tunnel leads to former stables (southern tunnel for servants and tradesmen ¹⁶ currently not within conservation area boundary)
- Dated 1833
- Rubble with ashlar dressings
- Round arch with rock-faced voussoirs and parapet with engaged pilasters
- Current condition: good

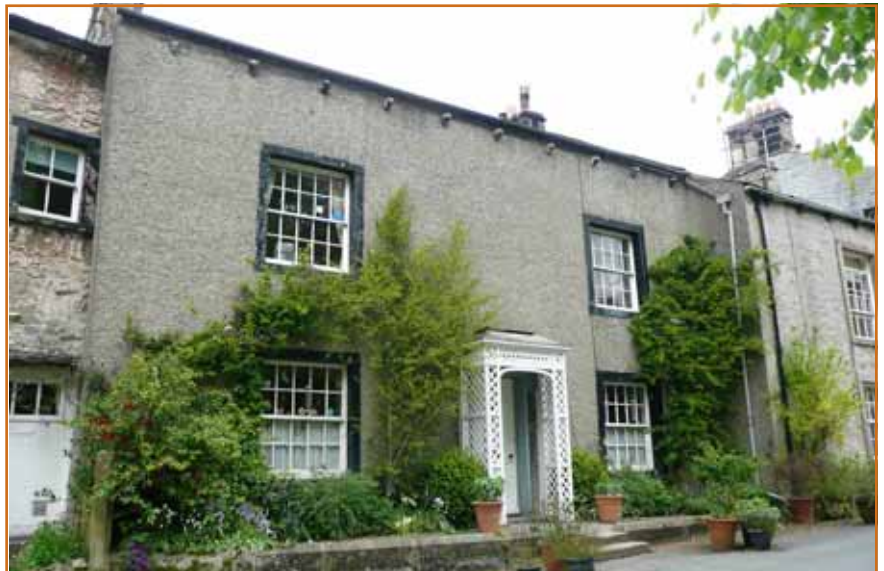
Figure 36: The Beeches, lower cottage (photo © Gaby Rose, YDNPA, 2010)

The Beeches (lower cottage) (figure 36), grade II listed –

- Cottage
- Early C19; door head dated 1686
- Pebbledash, painted stone dressings, stone slate roof
- 2-storey double-fronted building with central mid-C19 wooden entrance porch; sash windows with plain surrounds
- Included for group value
- Current condition: good, though paint of window surrounds is flaking off; vegetation may be harmful to façade if roots take hold in wall

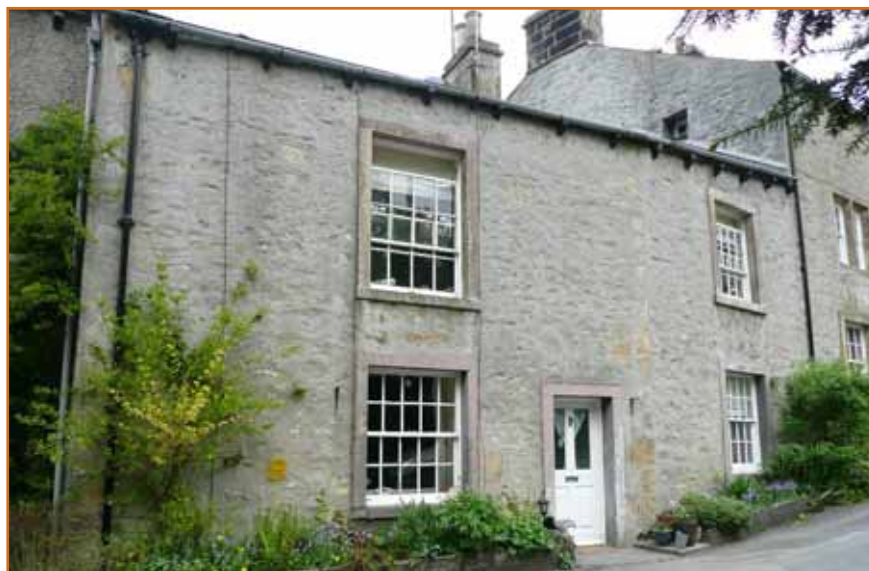
Figure 37: The Beeches, middle cottage (photo © Gaby Rose, YDNPA, 2010)

The Beeches (middle cottage) (figure 37), grade II listed –

- Cottage
- Probably C18 with C19 alterations; date stone 1689
- Slobbered rubble, painted stone dressings, stone slate roof
- 2-storey double-fronted building with curve to street and central quoins to left-hand bay; sash windows with plain surrounds
- Included for group value
- Current condition: good, though paint of window and door surrounds is flaking off

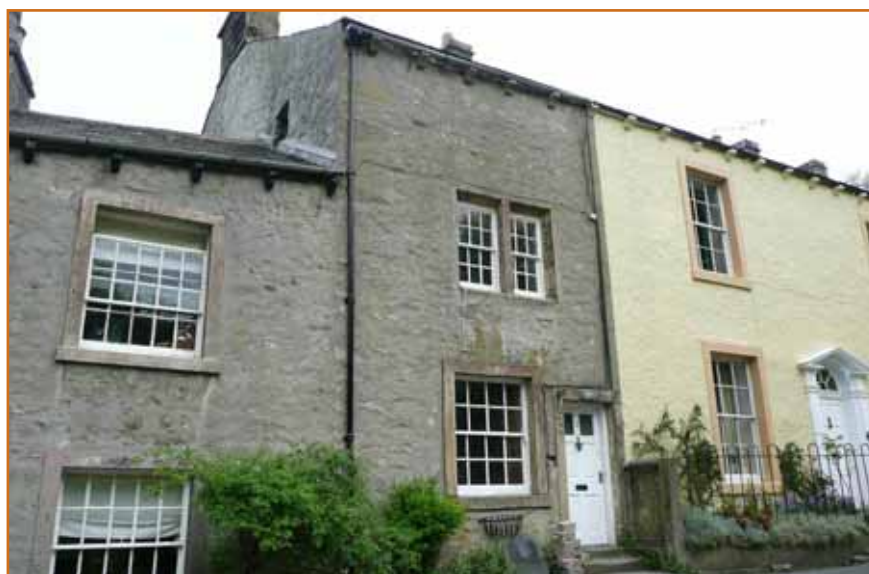
Figure 38: The Beeches, upper cottage (photo © Gaby Rose, YDNPA, 2010)

The Beeches (upper cottage) (**figure 38**), grade II listed –

- Formerly part of Fall View, now separate cottage
- Probably mid-C18 with early-C19 alterations
- Slobbered rubble, stone dressings, stone slate roof
- 2-storey 1-bay building; sash windows with plain or flat-faced-mullioned surrounds; pilaster marks junction with Fall View
- Current condition: good, though paint of window and door surrounds is flaking off

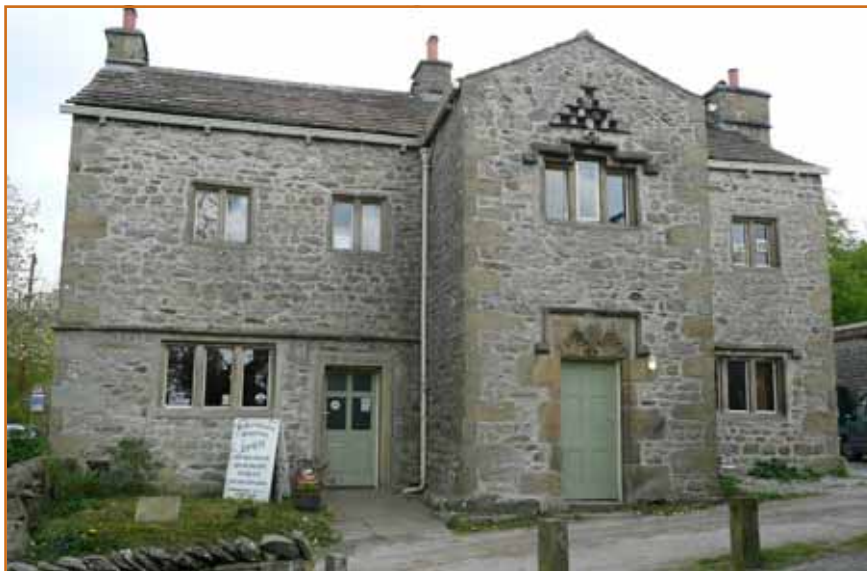
Figure 39: The Old Manor House (photo © Gaby Rose, YDNPA, 2010)

The Old Manor House (**figure 39**), grade II listed –

- Formerly manor house; community centre 1885-1942; one of the Farrers' home 1947-52; bought by WRCC in 1968, then transferred to YDNPA; sold in 2006¹⁷; now shop, café and bunk accommodation
- Dated 1701 with early-C20 alterations
- Strap-pointed rubble, stone dressings, stone slate roof
- 2-storey 5-bay building; projecting 2-storey entrance porch with pigeon holes in gable; chamfered mullioned windows and various hoodmoulds
- Interior: massive original inglenook fireplace and bread ovens
- Current condition: good

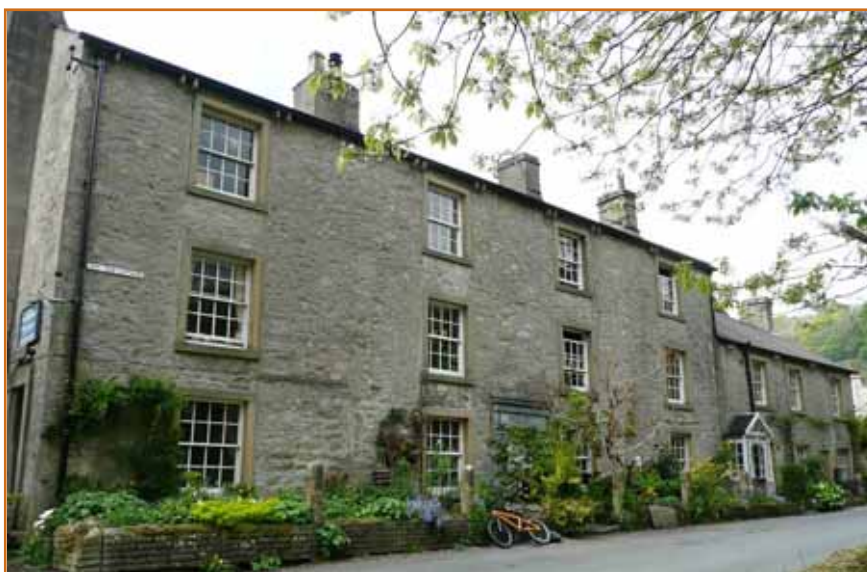
Figure 40: Yew Tree Cottages (photo © Gaby Rose, YDNPA, 2010)

Yew Tree Cottages (**figure 40**), grade II listed –

- Formerly house and cottage, now four cottages
- C18, re-fronted early C19
- *Yew Tree Cottage [...] was the home of James Farrer, probably the first Farrer to live in the village [...]. James seems to have bought the house about 1741, when he was an Ingleton solicitor, and lived there until 1763 when he lost most of his fortune and had to sell the house to pay off his debts. His son Oliver was also a solicitor but became sufficiently wealthy to buy back Yew Tree Cottage and most of the other Clapham property which his father had lost. Oliver's purchases became the foundation for the Ingleborough estate [...]*¹⁸
- Slobbered rubble, stone dressings, stone slate roof
- 3-storey 4-bay house with pigeon holes in right-hand gable and 2-storey 3-bay cottage; sash windows with plain surrounds and projecting sills
- Current condition: good, though some of window surrounds are starting to decay

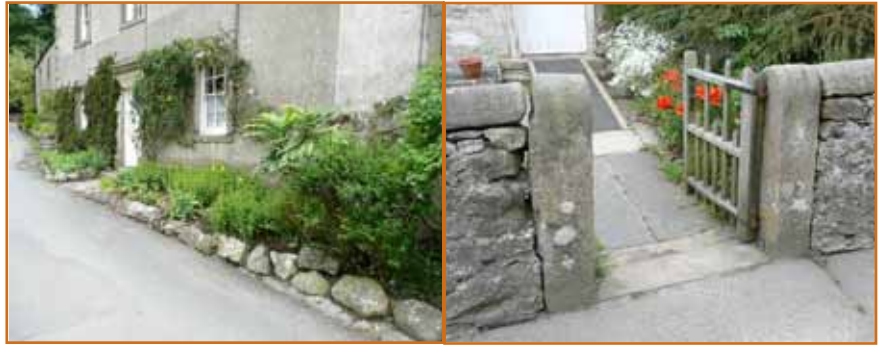
Figure 41: Front gardens
(photos © Gaby Rose, YDNPA,
2010)

Local details. A particular characteristic of the Clapham Conservation Area is the number of properties with very shallow front gardens or strips of vegetation on the road edge. Some of garden entrances still have stone gate posts in place. At Gildersbank, a short cobbled path leads to the entrance door. A terrace just north of the fork in Cross Haw Lane has stone flags for paving, as do the paths towards the church entrance in the graveyard, but on a larger scale. Garden boundaries are very individual: some have dry or mortared stone walls, while others have merely a stone kerb or lines of cobbles (**figure 41**), or even vertically aligned slabs of limestone pavement. At the north-western end of the village, timber access doors are incorporated within some of the tall boundary walls. Several walls of parapet height show evidence for former cast-iron railings, although railings have managed to survive in a few locations. The wrought-iron gates to Ingleborough Hall are an attractive feature on the east side of Church Avenue.

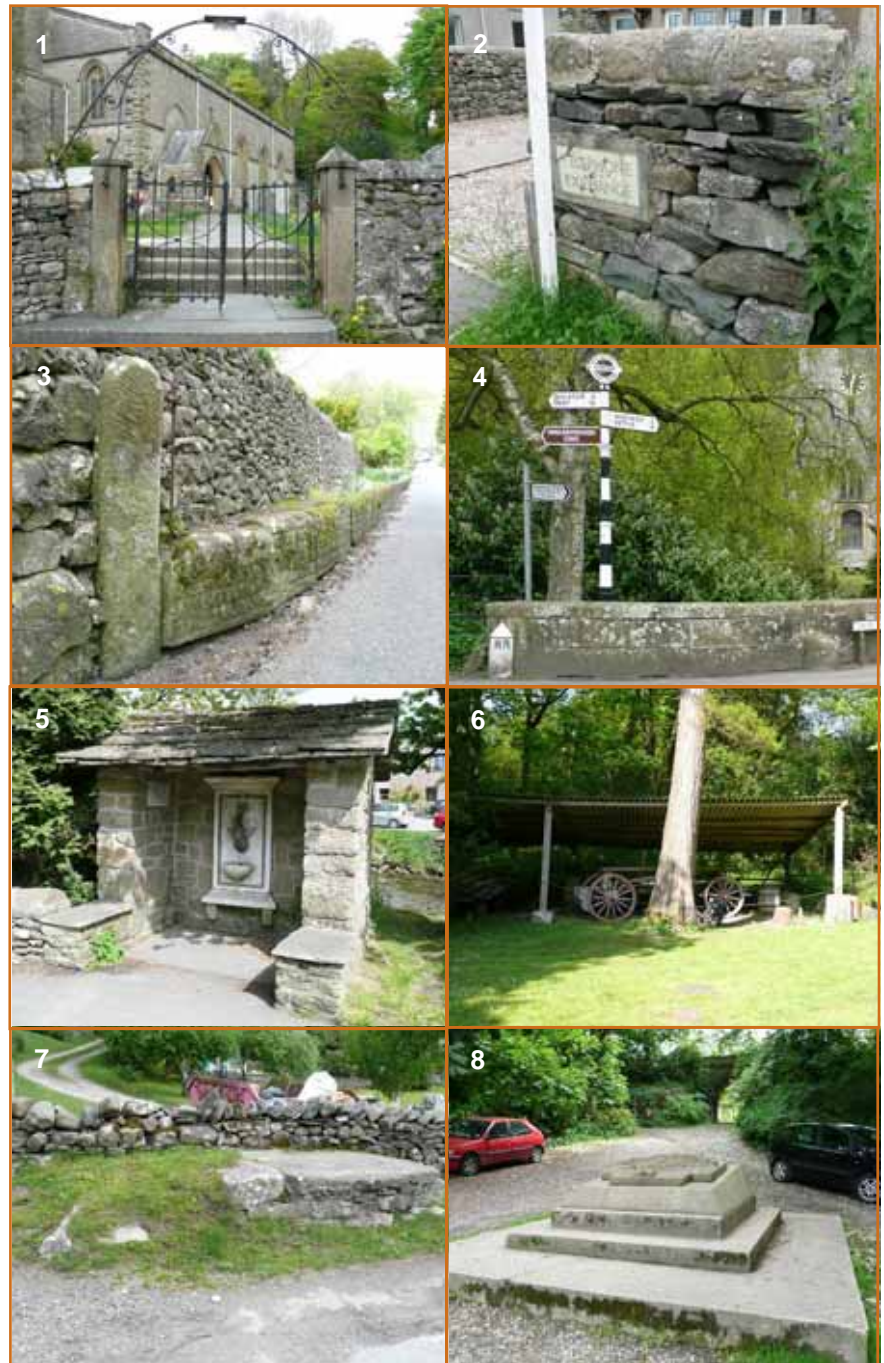
Figure 42: Public realm (photos © Gaby Rose, YDNPA, 2010)

The Clapham Conservation Area has some interesting features in the public realm (figure 42):

- Ornate gateway to church (1); the design of the gate doors is repeated in the gates further east in the wall.
- A 'telephone exchange' sign at the bottom end of Cross Haw Lane indicates the former function of the building plot (2)
- Historic stone post and large-stone-slab kerbing (3), an unusual feature which is repeated at the private gardens of Yew Tree Cottages further north (figure 40). The horizontal relief dressing is a characteristic of Clapham, also found on quoins, window surrounds and even troughs.
- West Riding County Council signposts – although in the example illustrated the additional car park signpost is a detractor – and bridge markers (4)
- Queen Victoria's Diamond Jubilee memorial drinking fountain (5). Conservation work to this was grant aided by the Authority in 1995.

- Open-air exhibition at 'Cave & Trail' (6). This is the starting point of the nature trail leading by the bobbin mill along the west side of the lake to the Ingleborough caves; the path has been accessible to the public on payment of a small fee since the late nineteenth century
- Churn stands on Eggshell Lane (7) and at Bull and Cave Farm. These roadside platforms, dating from the late nineteenth and early twentieth centuries, allowed easy loading of milk churns onto carts and trucks. Full milk churns awaiting collection would have been a common sight along Dales roads, so these functional structures provide an attractive link to Clapham's agricultural past.
- The Millennium Stone (8) opposite the church

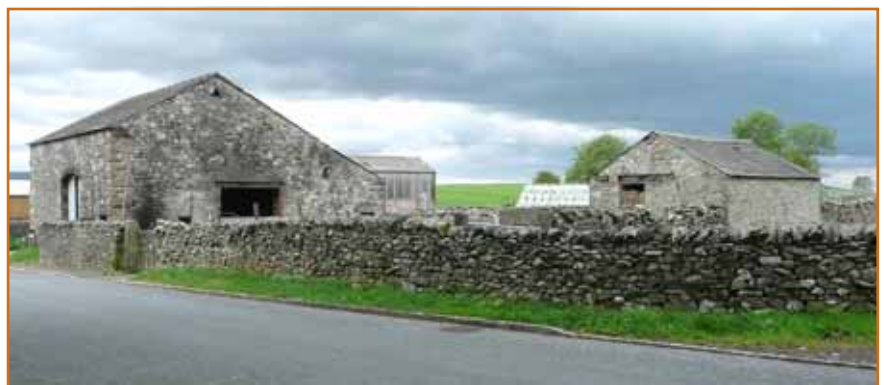
Figure 47: Small barn (on the right) along Cross Haw Lane (photo © Gaby Rose, YDNPA, 2010)

(3). The inclusion of a small barn along Cross Haw Lane (figure 47) which is within the Craven District Council part of the conservation area. It forms a pleasant group with the larger barn on the left which is currently within the conservation area. The barns occupy the site of a tollhouse erected c.1824 to control access to the new road to Ingleton, built in place of the old turnpike road at the head of the village¹.

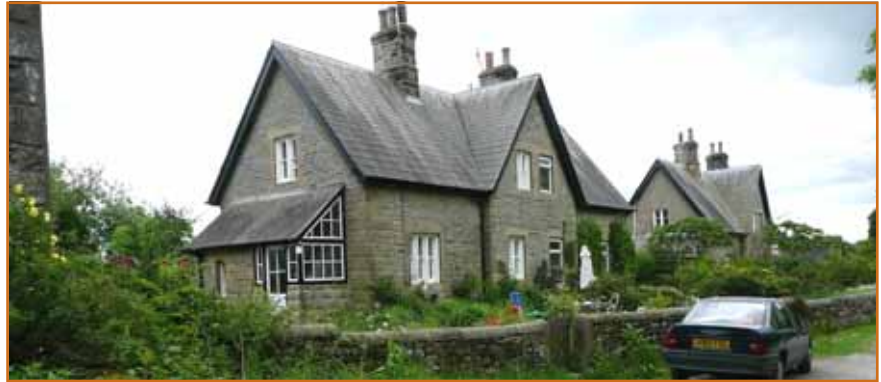
Figure 48: Estate cottages along The Green (photo © Gaby Rose, YDNPA, 2010)

(4). The inclusion of semi-detached estate cottages along The Green (figure 48). They were built c.1884 to designs reputed to have been approved by Prince Albert (died 1861) as 'enlightened dwellings for the labouring classes'². Despite a number of uPVC window replacements which detract from their group appearance, these buildings appear otherwise in a remarkable original condition, including their

conservatories. Their distinctive architecture makes a positive contribution to the Clapham Conservation Area and is indicative of the nineteenth century development of Clapham as an estate village. They are within the Craven District Council part of the conservation area.

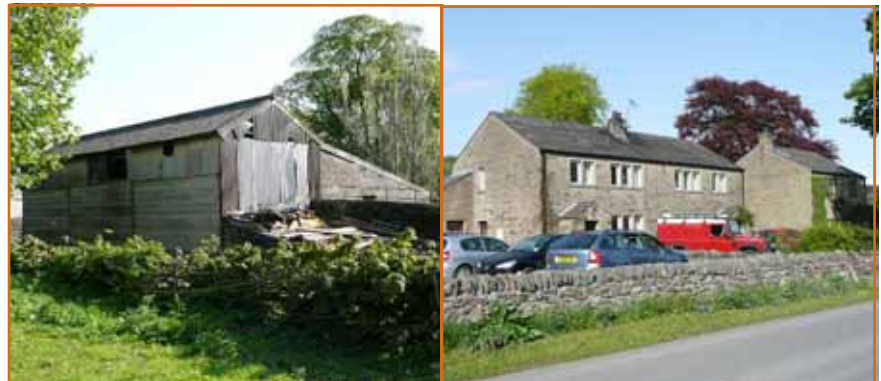
Figure 49: Part of Home Farm and development along Old Road (photos © Gaby Rose, YDNPA, 2010)

(5). An area suggested for removal from the designation is a group of very undistinguished twentieth-century structures, part of Home Farm, as well as more recent development along Old Road (figure 49). Although the latter houses are of a good standard design, they do not contribute to the character of the Clapham conservation area in the regard that they are physically too removed – especially with the New Inn car park in between – and thus do not feel part of the historic core. Regarding Home Farm, the make-shift structures have no physical qualities that are reflected in the appearance of the Clapham Conservation Area. If they are excluded from the revised boundary, any future replacement will need to take account of their close proximity to the conservation area and consider a more sympathetic design.
